A NEWSLETTER FROM LESCO RESTORATIONS, INC.

SEPTEMBER 2003

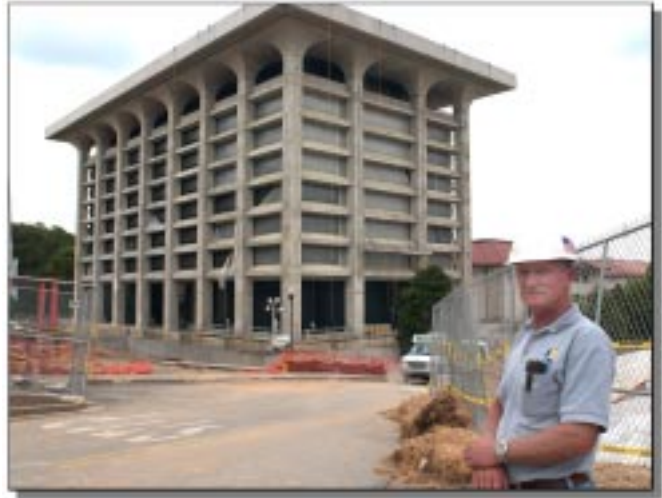
Lesco superintendent Dean Robinson overcame the challenges of restricted work sites during his recent assignments - Woodruff Library, shown here, and the dorms at Emory's Clairmont campus.

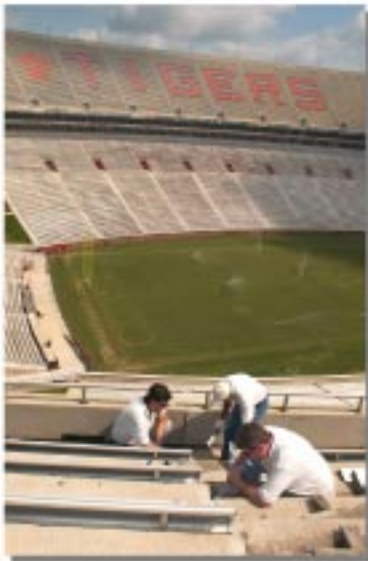
Death Valley Ready for Tiger's Roar After Repairs

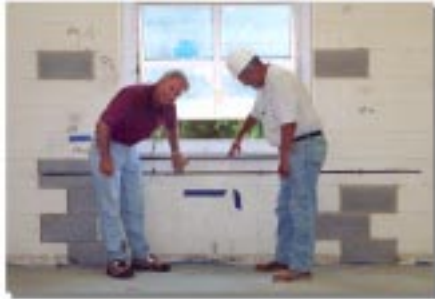
Lesco's Doug Dizney (right) and Jim Hadley of Sika Corporation inspect work.
