SOLUTIONS

A NEWSLETTER FROM LESCO RESTORATIONS, INC.

DECEMBER 2003

Lesco Keeps Parking Decks Safe and Functional Through Regular Inspections and Maintenance

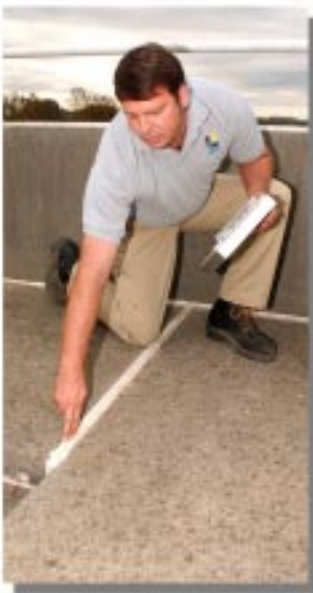
Sealant joints that are properly maintained prevent water from penetrating and creating problems below.

Water leaking through failed sealant joints mixes with the chloride salts in concrete and becomes a solution that damages auto paint. (In compliance with Murphy's Law, it drips on the most expensive cars below.)

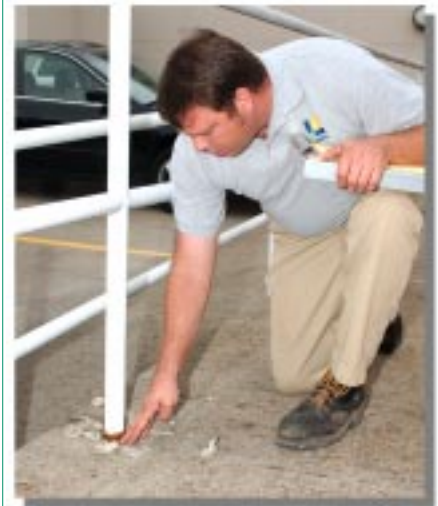
Concrete around this railing has crumbled, making the railing less secure and opening the way for water to penetrate and do more damage.

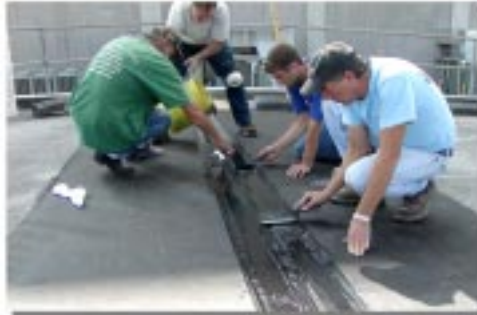
Lesco crew members go to work on the sealant joints at MUSC in Charleston.

Charleston had developed serious expansion joint problems. The existing metal joints were bent and damaged from years of traffic, and no longer served as a protective water barrier and expansion joint.

Lesco is an approved installer of Watson Bowman Acme systems, including the Wabo Crete Membrane Expansion Joint Systems. With the assistance of Jim Schwartz of Watson Bowman Acme, Lesco completed the repairs and provided the client with a five-year joint warranty, as now required by many specifications.
